Impact Assessment Study

Rejuvenation work at Nandi Lake and restoration of traditional structures (Kalyani and Gunduthopu) at Sultanpet village, Chikkaballapura district, Karnataka

Study commissioned by United Breweries Limited

Study conducted by Nous Consultants

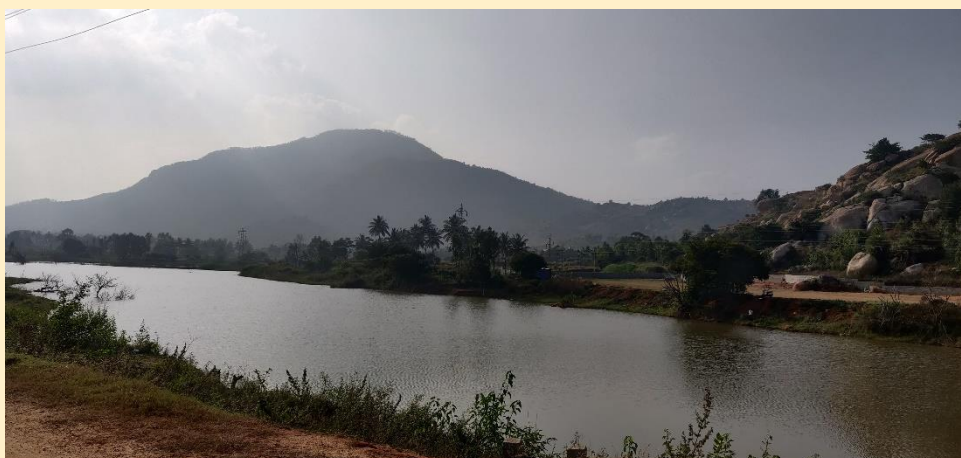
Photo 2: Nandi/Sultanpet Lake

When the review team visited the site in December 2023 – roughly 2.5 years after the lake bed cleaning had been done – it found the lake was still full. During our meetings with farmers and community members, we asked them why was the lake now full – and most people were emphatic that the work done by UWB/UBL had contributed to this, though many also said that in the past the rain had been poor and thus the lake had stayed empty.

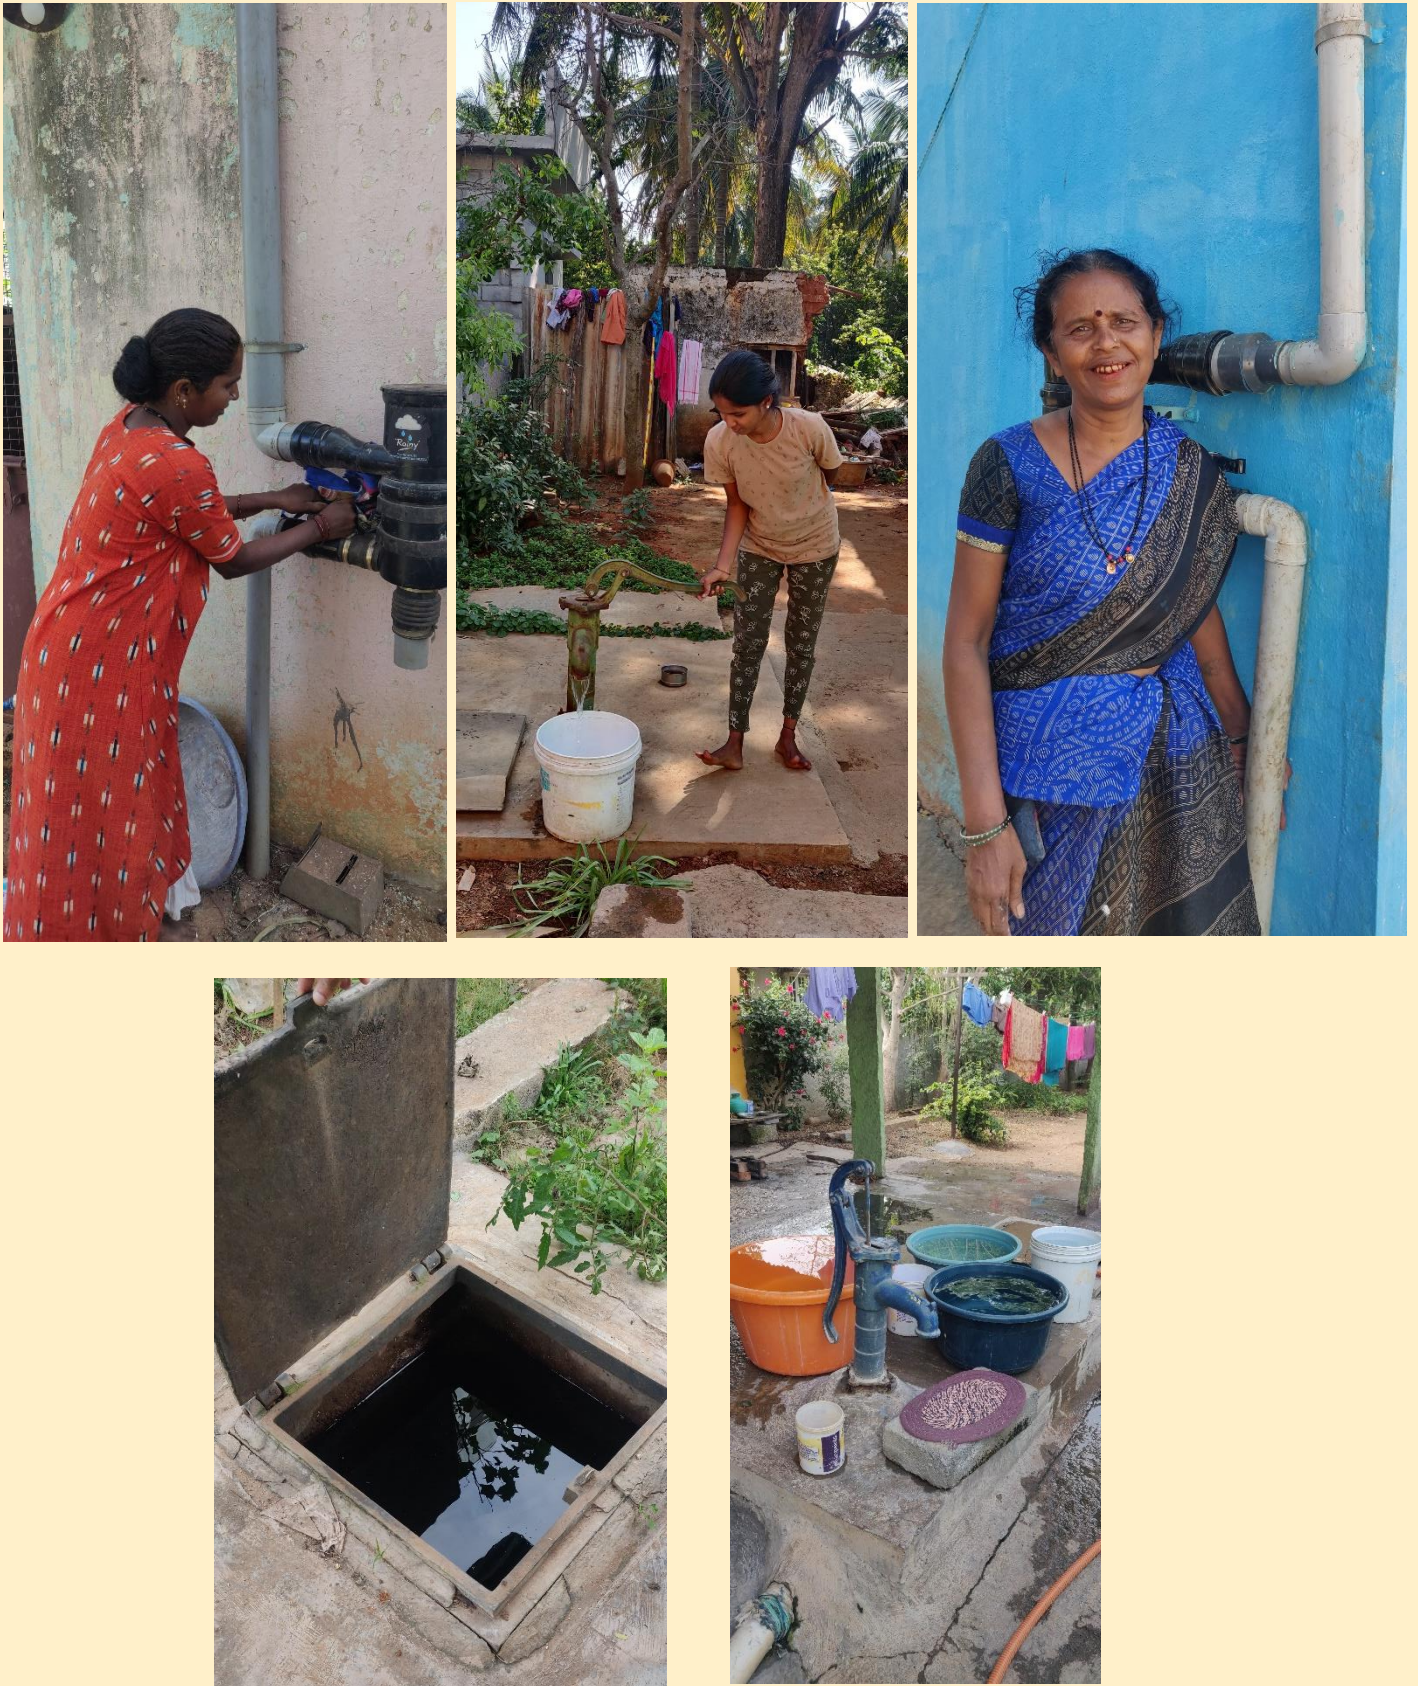
Photo 7: Field photos of some RWH Systems

Overall, if we define a fully functional RWH system as a water tank which has the water pipe connected to the roof and to the tank, a functional filter and a functional hand pump, then we can say that only 31 out of 180 RWH systems (17%) are currently fully functional.

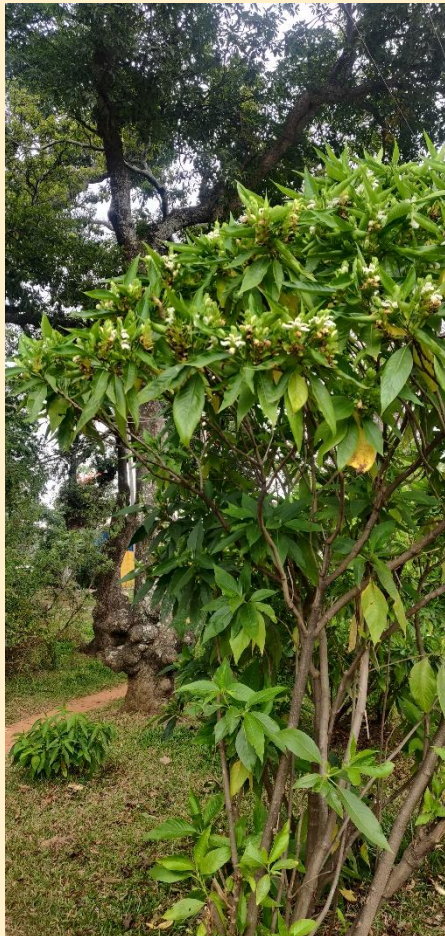
Photo 8: New plantation and some old trees at Gunduthopu

- ii. From the immediately 'after-intervention-photos' that are part of the completion report, the work had made a lot of difference to the condition of these two public spaces. However, the challenge appears to have been lack of maintenance on part of the Panchayat, because of which both the Kalyani and the Gunduthopu today appear dilapidated again.

Gunduthopu were visible. The fact that about one-third of the Gunduthopu area has been taken up for building a road, some of the saplings were lost in this.

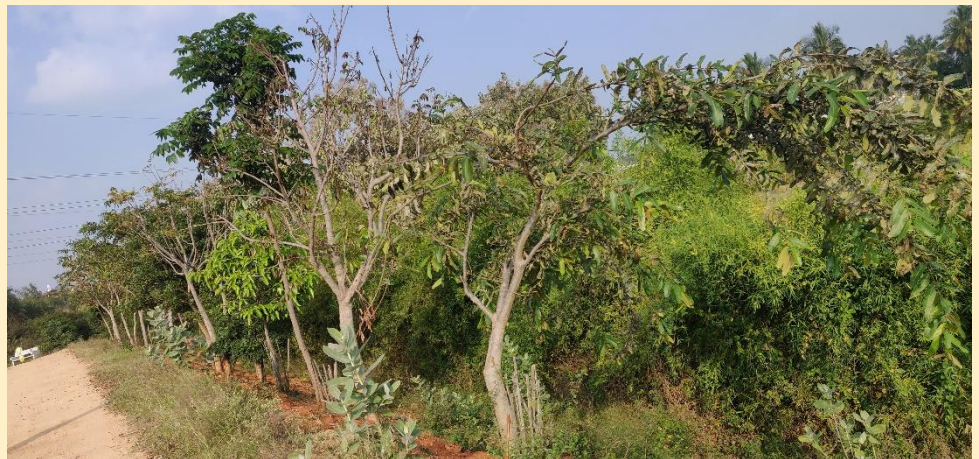
Photo 9: Plantation on the lake bund near the overflow

As per the project documents, plantation was undertaken at two locations in the Panchayat – the Gunduthopu and on the bund of Nandi Lake. A total of 3500 saplings were planted and are surviving. The main purpose of this intervention was to enhance soil and water conservation in the area. The saplings were planted over 2019, 2020 and 2021.

Similarly, greater care could have been paid to the plantation part of the project. The survival percentage of the saplings that were planted appears to be low. A more precise count could not be done since there was no marking done to set out the new plantation. The survival may be poor due to inadequate post plantation care (watering, weeding, etc) or it could have been due to browsing by animals. No tree guards or fencing system seemed to have been put in place, which would have served the dual purpose of protection and identification.

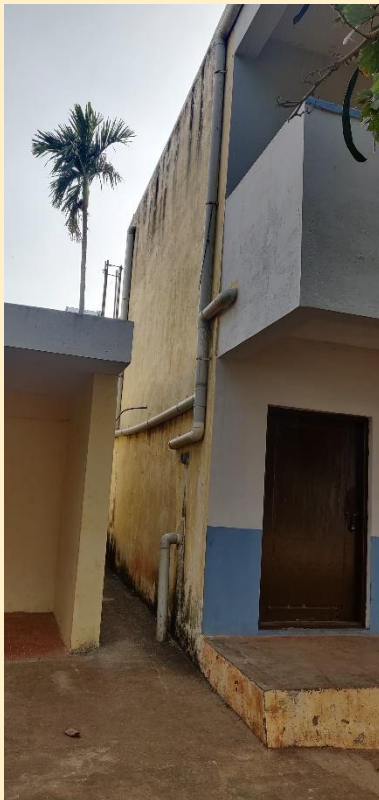
Photo 11: Pipe connections

During the visit, we found the rainwater harvesting unit to be in complete working condition. The pipes were in place and connected. The underground storage tank has a capacity of 14000 litres, and was full. The filter could not be seen since it was inside a

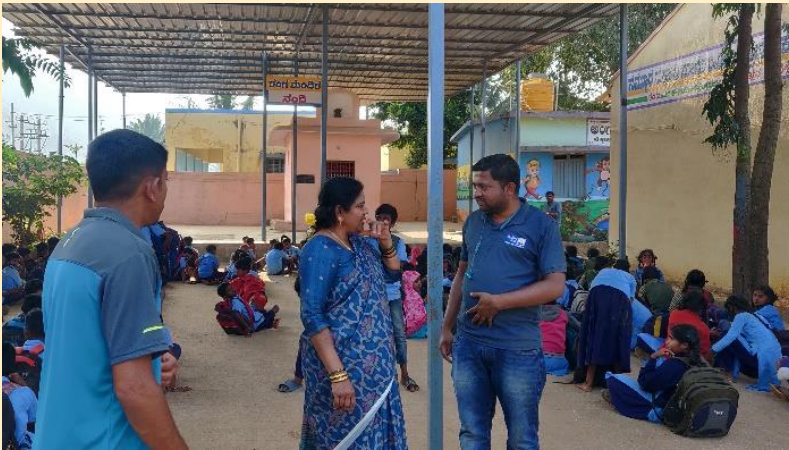
Photo 12: Nandi higher primary school

The survey team were told during the site visit that no rain water harvesting unit had been installed in this school, though toilet repair work had been undertaken.

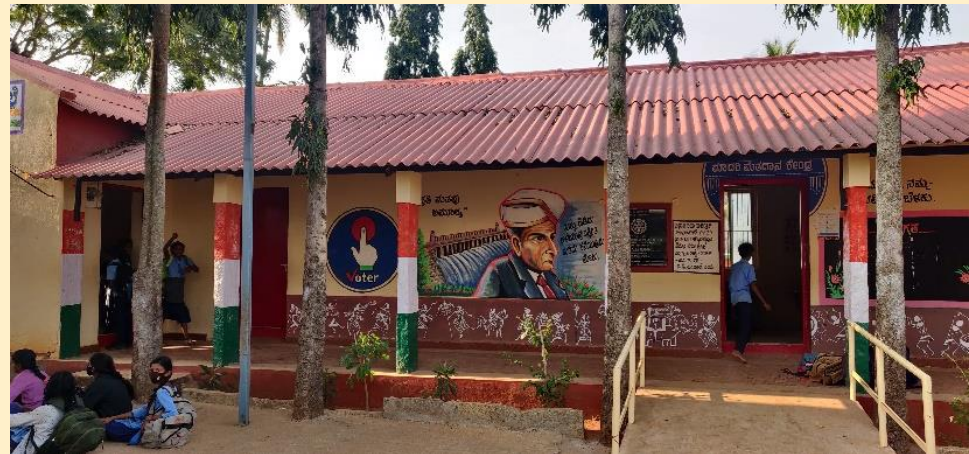
Photo 13: Painting work at the school

At the Nandi higher primary school, the painting and beautification work is very much visible though the toilets need repairs.

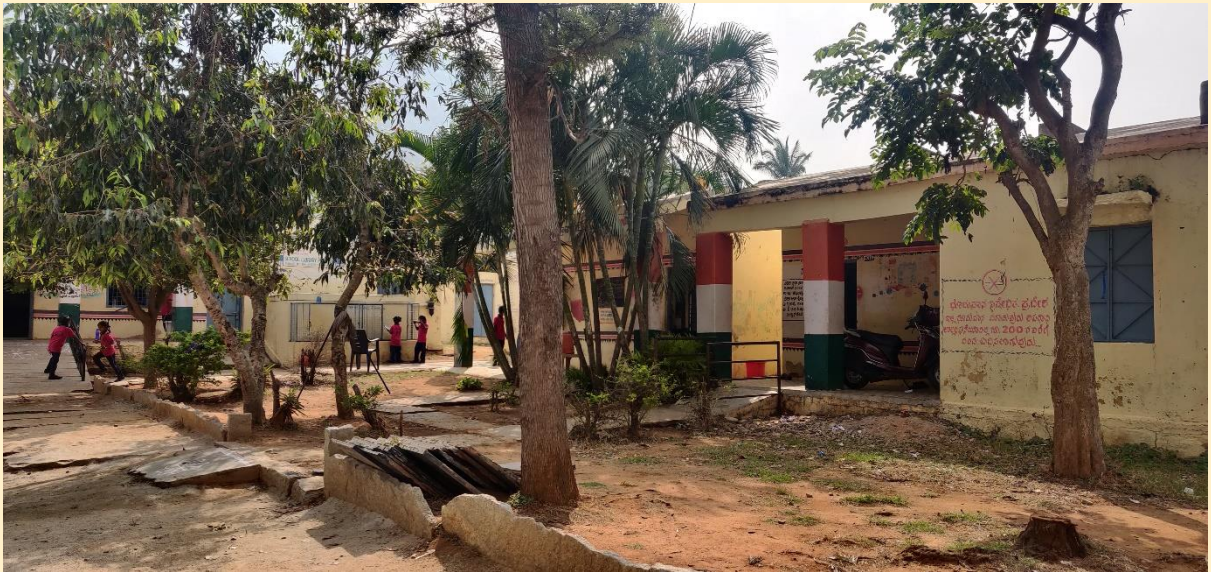
Photo 14 Primary School

The flooring, painting and toilet work at this school were found to be in fairly good condition. However, we were told on site that the RWH tank already existed in the school, and the project had only provided the pipes and the filter. The filter and the pipes were disconnected and currently not in use.

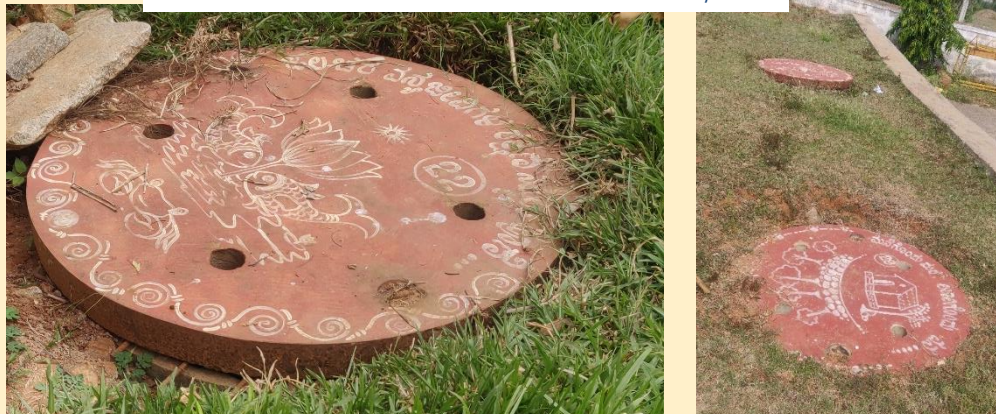
Photo 15: Percolation wells with clean visible tops

All the percolation wells that were found had the stated depth of 20 feet and the top lid was strong, well painted and numbered. Following from this, we can state that the inside work quality is also likely to be quite good.

Of the 81 percolation wells that were found, only 44% of them had clean, visible tops. This is important since the only flow into the well is from the top, and if the holes on the top get fully covered, then the well's effectiveness will gradually diminish. Hence, the well tops require regular maintenance (at least once a year, before the rains) to ensure that the garbage and silt from the top is removed.
